ASSESSMENT OF INTENSITY OF EROSION AND NATURAL COVERAGE OF TRACTOR ROADS IN POST-EXPLOITATION PERIOD

Muhamed Bajrić¹, Dževada Sokolović¹, Jusuf Musić¹, Velid Halilović¹

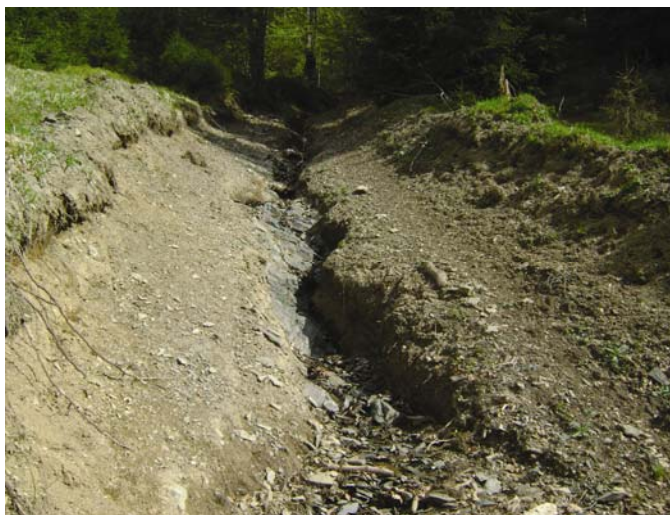
Photo 2. Impact of surface water on intensification of erosion processes (photo: BAJRIĆ, 2011.)

Maximum value of erosion degree is recorded on Location I (10 – 20%) in amount of 3.73. Reason for intensification of erosion processes can be found in visible presence of surface water along ruts of tractor roads, whose presence has probably caused ruts to deepen, and thereby intensify erosion process. Appearance of water, as the reason for intensification of erosion processes, is mentioned in works of REBULA (1991a and b), TOMAŠIĆ (1998), BAJRIĆ (2012). Along mentioned reason, on Location II with slope of < 10%, with the presence of water, we recorded movement of tractor in period between two surveys which probably could be one of the causes of intensification of erosion processes.

During surface drainage/flow-off, large numbers of micro flows appear, which interconnect with one another. Concentrated surface water possesses significant erosion power, and causes ribbing of area it flows over, which creates furrow erosion (KOSTADINOV, 2008). In cases of untimely undertaking of appropriate measures and further concentration of surface water, causes next level of accelerated erosion to appear– dike erosion (JAHIĆ, 2008, KOSTADINOV, 2008.). Mentioned phases of development of water erosion happens on tractor roads in cases when rehabilitation measures are not done, where in some extreme cases tractor road can turn into flooding flow.

Negative action of surface water on tractor road is clearly presented on photo 2.

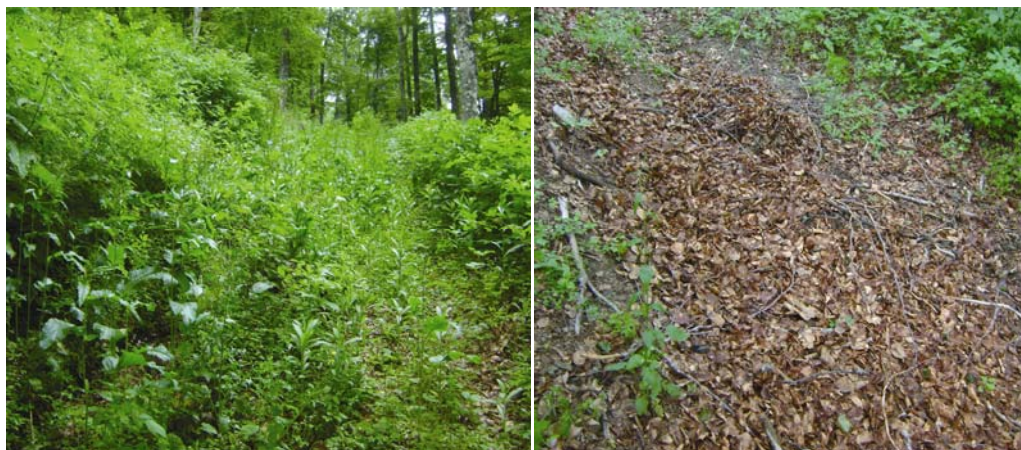
Photo 3. Natural appearance of grass vegetation and litter in function of prevention of erosion processes on tractor roads (photo: BAJRIĆ, 2011)

sunlight which precipitates grass growth. Besides mentioned, impact can also be made by somewhat better grass coverage in close vicinity to skid roads, and most likely grass seed by the power of wind found its way to skid roads, while smaller coverage of skid roads on Location I, could be explained by more intense erosion processes which disabled natural regeneration (impact of water flow per skid). Natural coverage and holding up of litter have important role in prevention of intensification of erosion processes on tractor roads (Photo 3).

Coverage by grass vegetation is more intense on sections of tractor roads where opening (of forest crop) is higher, i.e. on sections of tractor roads less covered by tree crowns. Coverage of tractor roads by litter is larger on sections which are more covered by tree crowns, this particularly relates to sections of tractor roads on locations II (10-20%), II (> 20%) and I (> 20%) with presence of broadleaved species (beech and oak).
